NATIONAL PROGRAM FOR INSPECTION OF NON-FEDERAL DAMS
GLEN LAKE DAM (CT 003..(U) CORPS OF ENGINEERS WALTHAM
MA NEW ENGLAND DIV AUG 79

4. TITLE (and Subtitle) Glen Lake Dam NATIONAL PROGRAM FOR INSPECTION OF NON-FEDERAL DAMS		5. TYPE OF REPORT & PERIOD COVERED INSPECTION REPORT
7. AUTHOR(s) U.S. ARMY CORPS OF ENGINEERS NEW ENGLAND DIVISION		6. PERFORMING ORG. REPORT NUMBER

The 380⁺ foot long dam is a concrete gravity section rising approximately 62 feet above the bed of the Sargent River. The dam is founded on bedrock with the deepest foundation extending to 75 feet below the top of the dam. The spillway at the right end of the dam, is a concrete ogee section 40 feet in width, with 9 feet of freeboard from the crest of the spillway to the top of the dam.

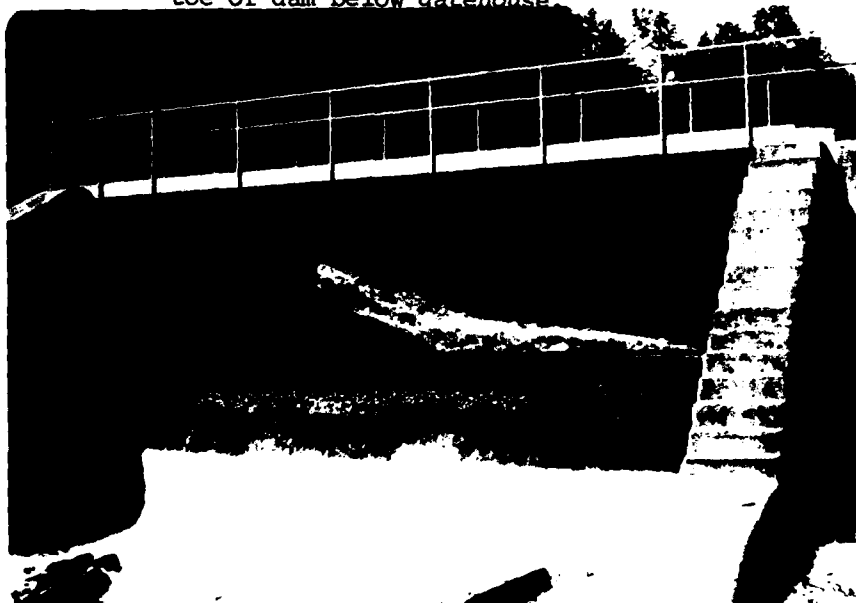
Spillway - The concrete ogee spillway spanned by a concrete service bridge is in good condition. The spillway and the upstream right wingwall, the side training walls and the short apron were repaired in 1969. The new reinforced concrete 3 foot high spillway weir which was anchored into the original concrete weir, is in good condition (Photo 4). The old concrete of the training walls and the apron has cracks with efflorescence, and 2 to 4 inch deep pockets which appear to have been worn or cavitated. Debris, including trees and stones, were noted on the weir and the downstream apron of the spillway.

PHOTO 4 - Concrete spillway weir spanned by foot bridge. Note cracking and efflorescence of abutment training wall.

1. The extensive wet area on the slope downstream of the left dike should be monitored periodically.
2. The deteriorated concrete areas of the spillway, the spillway training walls and the downstream face of the gravity section will be subject to further deterioration of the concrete if not repaired.
3. The trees on the downstream earth slope adjacent to the left side of the downstream face of the dam could be subject to overturning by the wind, which has potential for causing damage which would affect the stability of the dam.

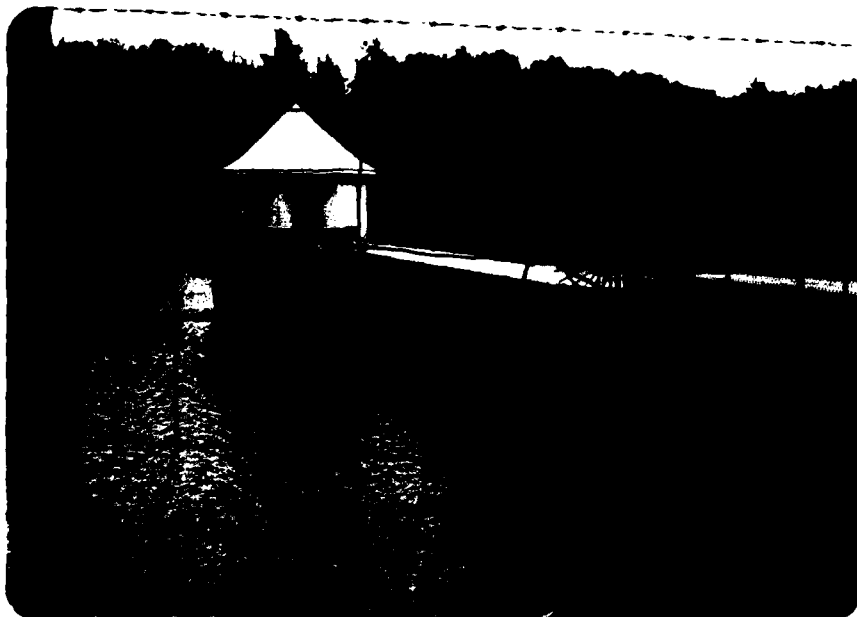
Crest and Upstream Face - No misalignment, deterioration, spalling or cracking were observed on the crest, including zones along the expansion joints 50 to 75 feet apart. The vertical upstream face near the crest does not exhibit significant cracks or deterioration from freeze-thaw or other influences. (Photo 5).

c. Appurtenant Structures - The gate house, which has a new roof, has no signs of visible deterioration (Photo 5). The downstream outlet masonry headwall appears to be stable (Photo 3). The submerged wet well drain and low level outlet at the base of the wall could not be observed. The gate valve operating mechanisms appear well maintained.

PHOTO 5 - Upstream face of dam and gatehouse from right abutment.
